Manhole Inspection Summary

Manhole # S53K__064MH

Insp Date: **7/29/08 11:34 AM**

Location Address: **800 fait Av**

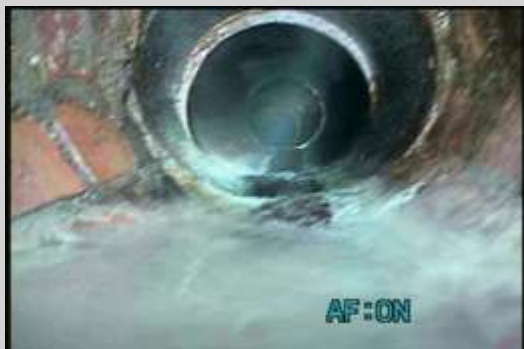
3 O'Clock Inflow

Invert Depth: 9.33 (ft.) Flow Characteristics: **Slow**

Infiltration: **None** Pipe Seal Cond: **Unknown**

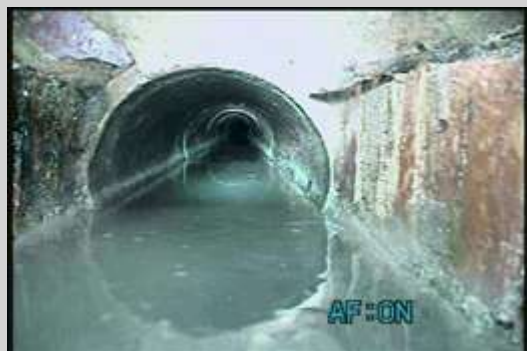
6 O'Clock Inflow

Infiltration: **None** Pipe Seal Cond: **Unknown**
